BAT ROOSTS IN THE ALPINE AREA: GUIDELINES FOR THE RENOVATION OF BUILDINGS

INTERREG IIIB
Living space network

October 06

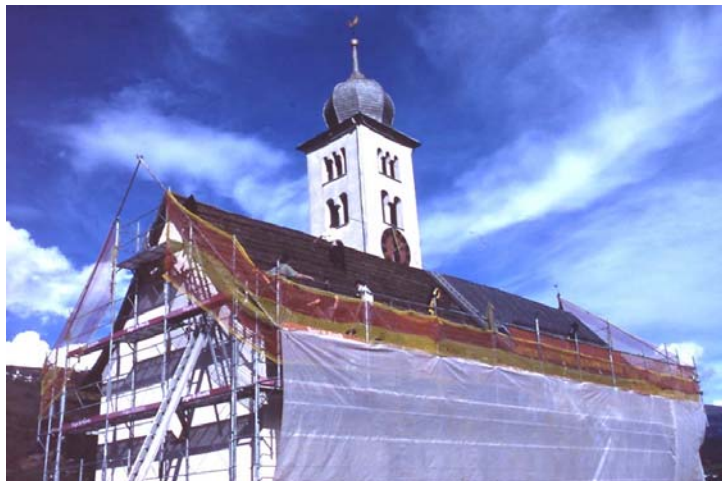
Fig. 4-1: The nursery of the greater horseshoe bats in Castrisch Church (Grisons, CH). Photo: E. Mühlethaler

Originally a cave-dweller (in Southern Europe), the greater horseshoe bat is now an adapted species in Central Europe. Its nursery roosts are invariably located in roof spaces (fig. 4-1).

The colony was located in the roof space of St Georgen's Church in Castrisch and consisted of about 120 individuals. Substantial renovation work was to be carried out at the church: renewal of the roof and facade, and restoration of the interior (fig. 4-1).

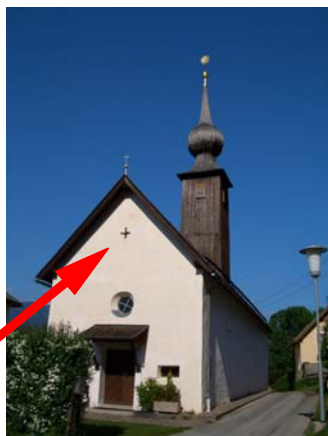
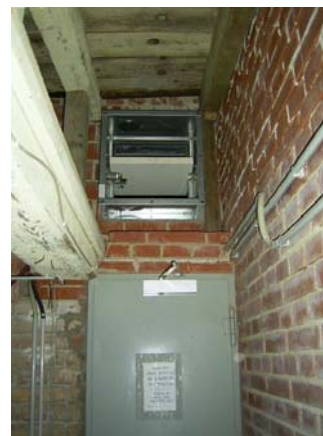
Fig. 4-4: The ingress and egress openings used by lesser horseshoe bats need to be accessible to fly through at all times. Sometimes they are of a relatively small diameter (Unteramlach Church, Carinthia, A). The picture on the right shows a fire shutter that was installed as an access opening for lesser horseshoe bats (Herrenchiemsee castle, Bavaria, D). Photos: K. Frühstück, A. Zahn

Unobstructed access (both incoming and outgoing) is a basic requirement if lesser horseshoe bats are to colonise a building. They prefer larger openings but sometimes even smallish ones can be sufficient (the smallest opening would have a diameter of about 10 cm). Anti-pigeon grids make it impossible for lesser horseshoe bats to establish themselves, as a rule.

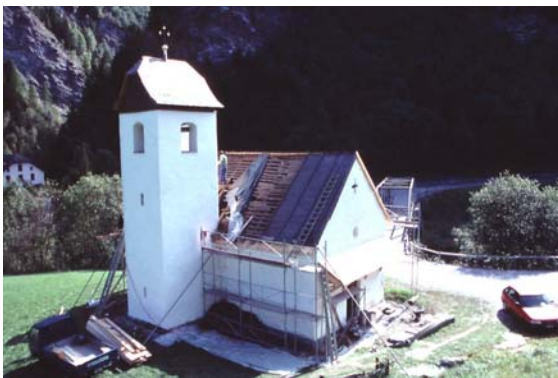
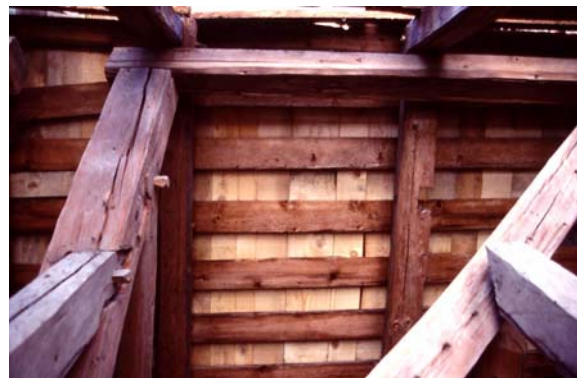
Fig. 4-5: Renovation example at Peiden Bad Church (Grisons, CH). Interior space after renovation: the old wooden shingles were replaced by roof boarding consisting of untreated boards. Photos: E. Mühlethaler, M. Lutz

Another measure taken was the maintenance of the sheet metal roof. As the wooden shingles had been fastened with hand made nails, the new metal panels could not be fitted onto the shingle beam (requiring that the nails penetrate the panels). That would have been the best solution from the point of view of bat conservation because it would have kept the present roof construction. However, in order to change the micro-climate as little as possible, the wooden shingles were replaced by roof boarding consisting of rough hewn and untreated planks. The metal panels were fitted directly onto these (without back ventilation) (fig. 4-5). To increase the quality of the micro-climate, all the existing openings between the wings of the roof and the capstone, except the two used by the lesser horseshoe bats as incoming and outgoing access passages, were blocked off with boards. In this way, it was also possible substantially to reduce the draughtiness that used to be a feature of the roost area.

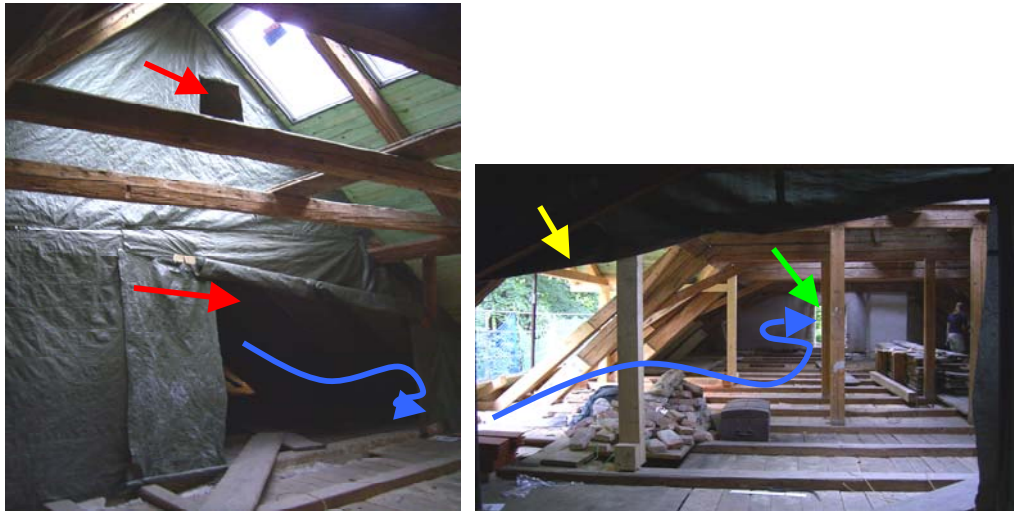
Fig. 4-6: Renovation of a power station and a residential building in Aschau (Bavaria, D.) The bat area is temporarily screened off using sheeting (picture on the left), with an open passage for incoming and outgoing access (red arrow on top) and an area open only during the night (red arrow at the bottom). The residential area to-be (picture on the right), seen from the bat area, with the future roof terrace opening (yellow arrow), and the original egress and ingress opening (green arrow). The animals' flight path towards the opening is marked by blue arrows. Photos: A. Zahn

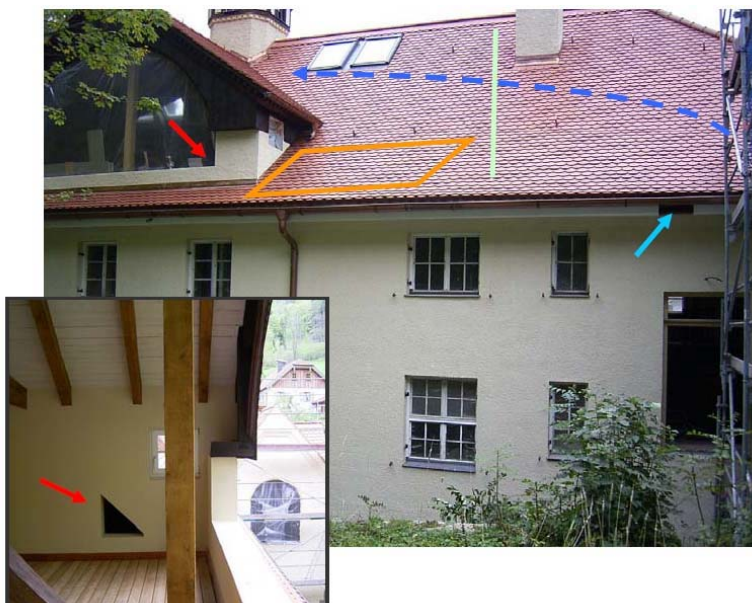
Fig. 4-7: Renovation of a power station and a residential building in Aschau (Bavaria, D.) The situation after the renovation in 2004 (rear side view of the building). Green: boundary between the residential area (left) and the bat area (right). Dashed blue line: former flight path for the ingress and egress opening. Light blue arrow: newly made opening that was not known to the animals in the previous year (2003) and which they do not use. Red arrows (large and small picture): additional opening on the roof terrace (there had been a large opening in the roof here in 2003). This which was accepted by the animals. Orange: unused space providing an access passage between the new opening on the balcony and the bat area, and skirting the residential area. Photos: A. Zahn

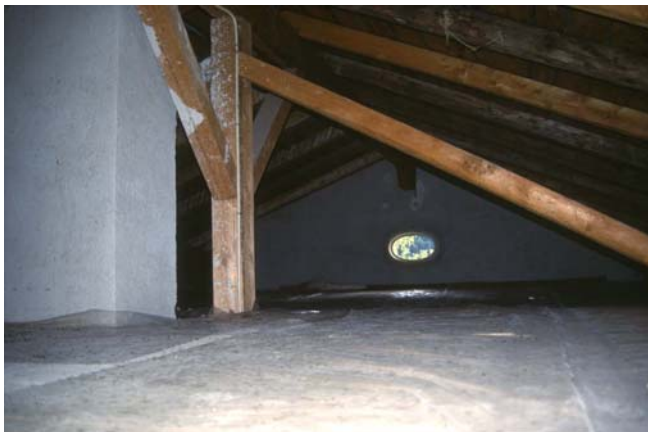
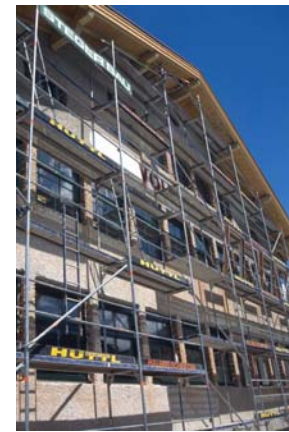
Fig. 4-8: Renovation example Primary School in Wald in Pinzgau (Salzburg, A). Thermal insulation was fitted on the roof space floor instead of the roof itself. The insulation boards were covered with a sheet to catch the droppings; in the background you can see the round egress opening. The external scaffolding was accepted by the animals. Photos: M. Jerabek

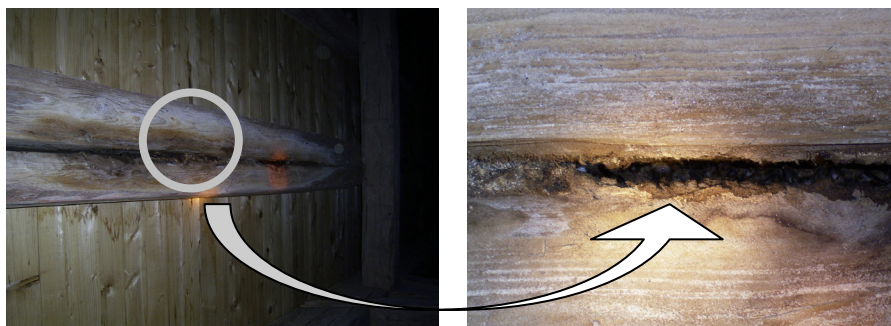
Fig. 4-10: Hanging place of the Brandt's bat at a roost located in a gap in the roof space (Burgrain, Bavaria, D). The hiding place is located in the ceiling of a multi-storey loft. Photos: A. Zahn

In buildings, hanging places are encountered particularly in lofts, although the animals populate the nooks and crannies (e.g. in false ceilings, gaps between beams, or between metal sheeting and wall, as well as holes in beams, see fig. 4-10).

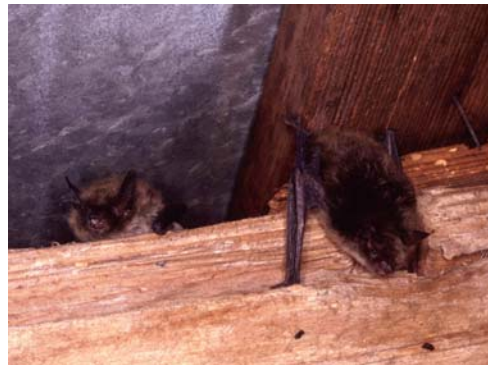
Fig. 4-11: A hanging place of whiskered bats, located in the gap between a metal roof and the wood. Photo: A. Zahn

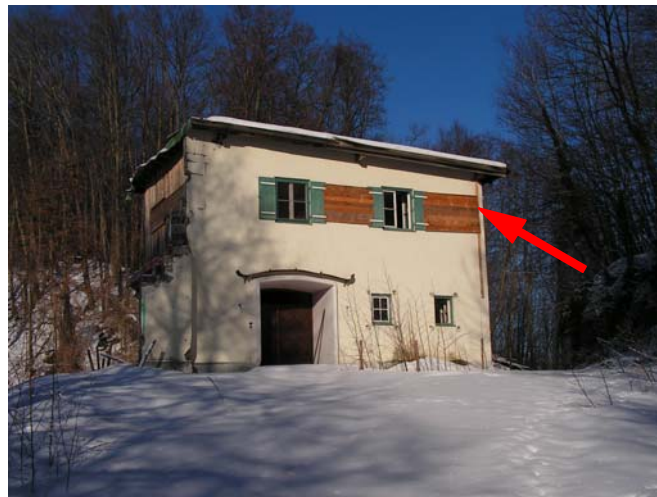
Fig. 4-12: Factory canteen, Murnauer Moos (Bavaria,D). Between the windows bat boards were fitted. So far they have been accepted only by a few individual animals. The colony still resides behind the soffit, as before. Photo: B. Wimmer

The alternative roosts were scarcely accepted. A few individuals were found only behind the panelling on the south and west sides. However there was a draught behind the new soffit, and in part also behind the new panelling. Moreover, the new roosts probably did not warm up in the same way as the old ones because the wood had not been painted. The colony now almost exclusively uses the preserved soffit on the east side. In 2005, over 270 adult animals were counted.

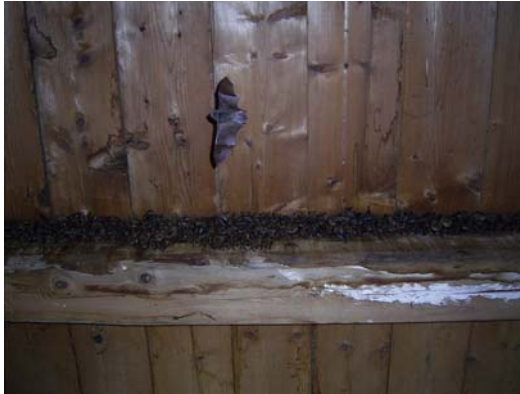
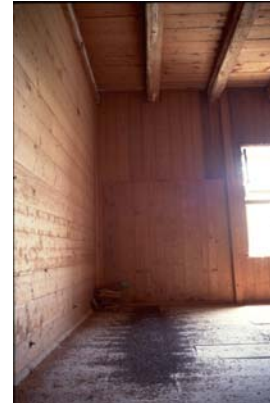
Fig. 4-15: Geoffroy's bats at the hanging place, and a typical hanging place situation in Maxelrain (Bavaria, D). The characteristic discoloration of the beams with urine and droppings is noticeable. Photos: A. Zahn

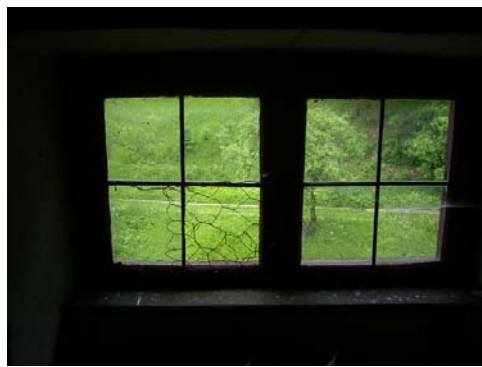
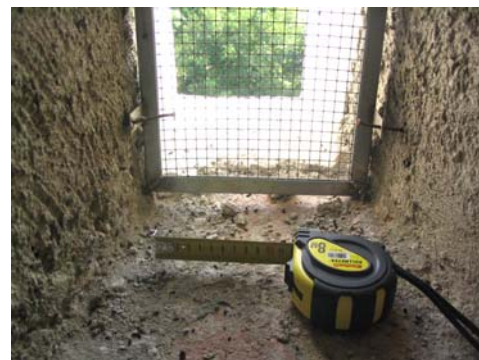
Fig. 4-16: Ingress and egress openings of roosts of Geoffroy’s bats in Bavaria (left) and Slovenia (right). Photos: A. Zahn, K Jazbec

The ingress and egress openings in five colonies in Slovenia, however, were located at a height of only between 1.5 and 3 cm from the ground (for example gaps between a grating and a wall). This makes it probable that the animals are not able to fly through them. (fig. 4-16).

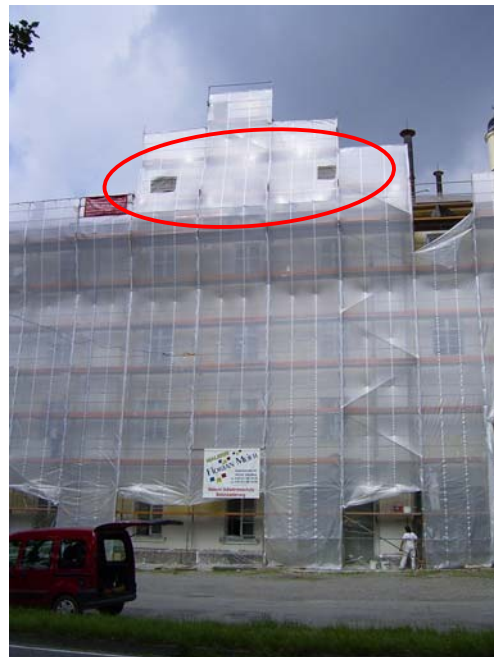
Fig. 4-17: The egress openings of the colony of Geoffroy's bats, consisting of about 250 animals, is located on the top floor of the attic. In 2005 the facade was renovated. Photo: A. Zahn

Geoffroy's bats seem to tolerate external scaffolding, provided the egress openings are not directly obstructed. This means that outdoor work that does not involve vibration or noise can be carried out even during the nursery period. However, it must be ensured that any netting used in the area of the egress openings has corresponding gaps in it (fig. 4-17).

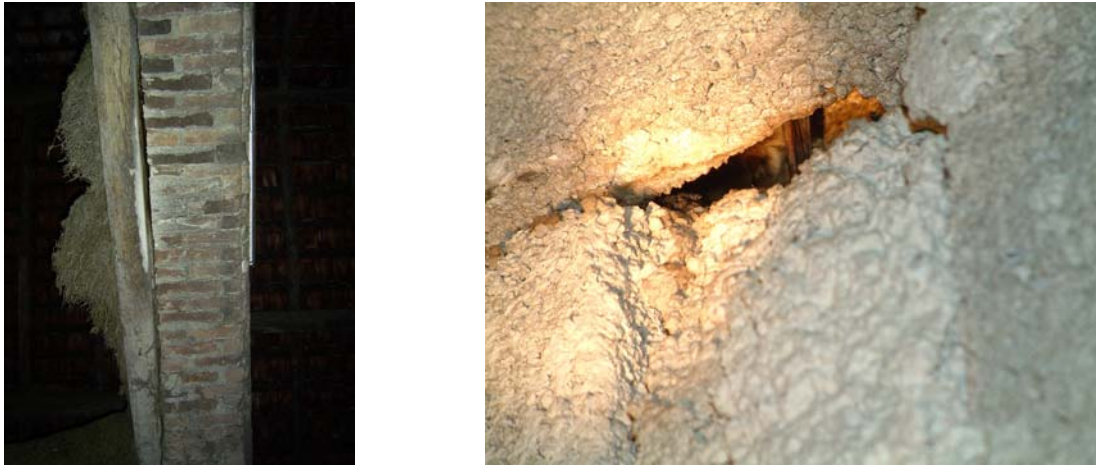
Fig. 4-18: Hanging places of Natterer's bats in a shed, between a beam and a wall (Westerndorf, Bavaria, left), and in a cavity in the stonework at a machine shop (Kehrham, Bavaria, D). Photos: A. Zahn

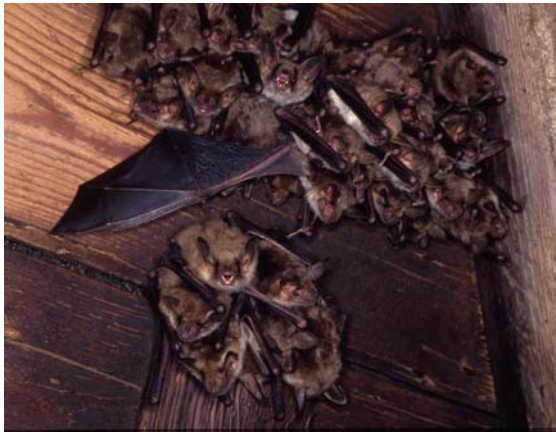
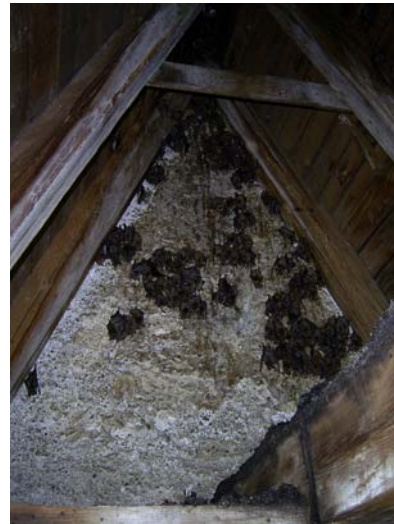
Fig. 4-19: Mouse-eared bats at a hanging place under the ridge of a roof (left) and one on a wall used at times of high temperatures (right). Note the brown discoloration around the hanging places, the boards of a lighter colouring because of the minerals in the dried urine, and in the foreground of the right-hand picture, droppings on supporting beams. Photos: A. Zahn

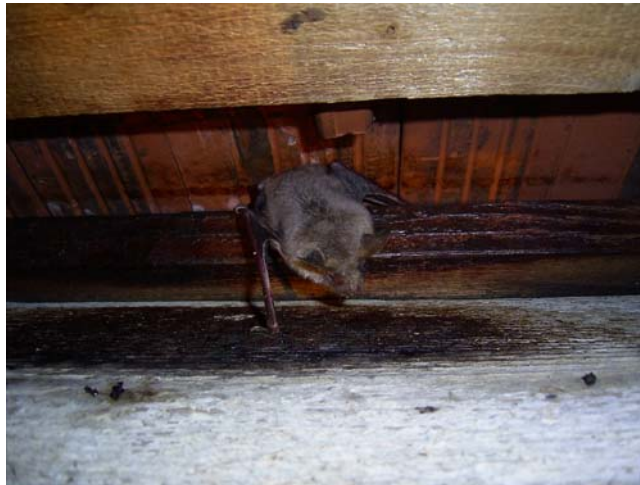
Fig. 4-20: Brown discoloration of wood, brick and wall at a hanging place of male mouse-eared bats. Photo: A. Zahn

Tip: Hanging places can be identified by means of the droppings below and of a black-brown discoloration of boards and walls.

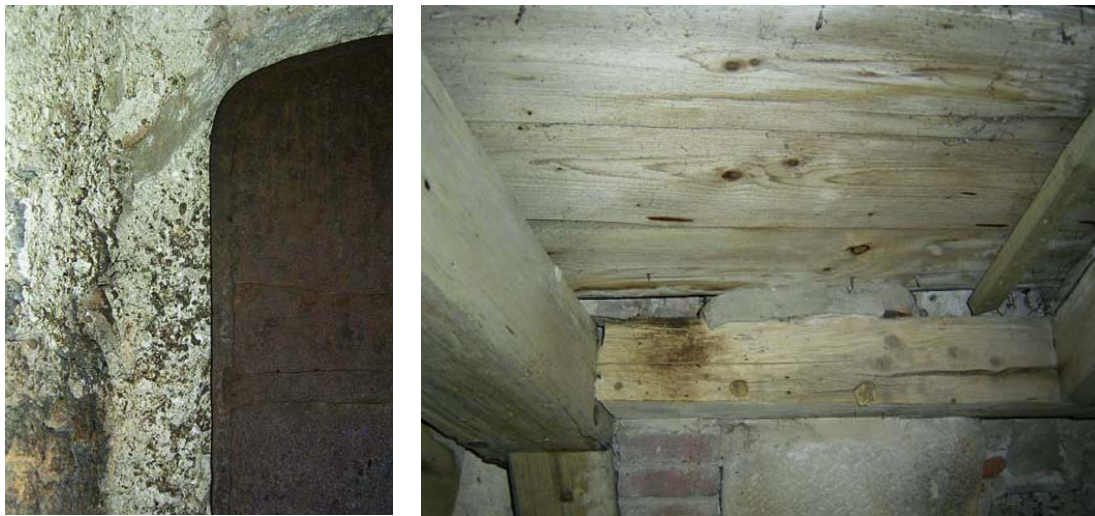
Fig. 4-21: Gaps through which the animals can slip into and out of the roost: between a door and a wall (left) and at the base of the roof (from the outside the animals appear under the eaves gutter). The place where the mouse-eared bats land on the wall and beam is discoloured brown. Photos: A. Zahn

Tip: The transit and egress openings that can be used in free flight may only be identifiable by means of the droppings on the floor and on the wall, in the environs of the egress opening. (Note that these may be inconspicuous with small colonies.) Smaller gaps that are used can be identified by the brown discoloration of the landing place in front of the opening and on the surfaces over which the animals climb. Usually it is easier to spot them in the roost than it is from the outside. However sometimes it is also possible to identify them from there (remember to take your binoculars!).

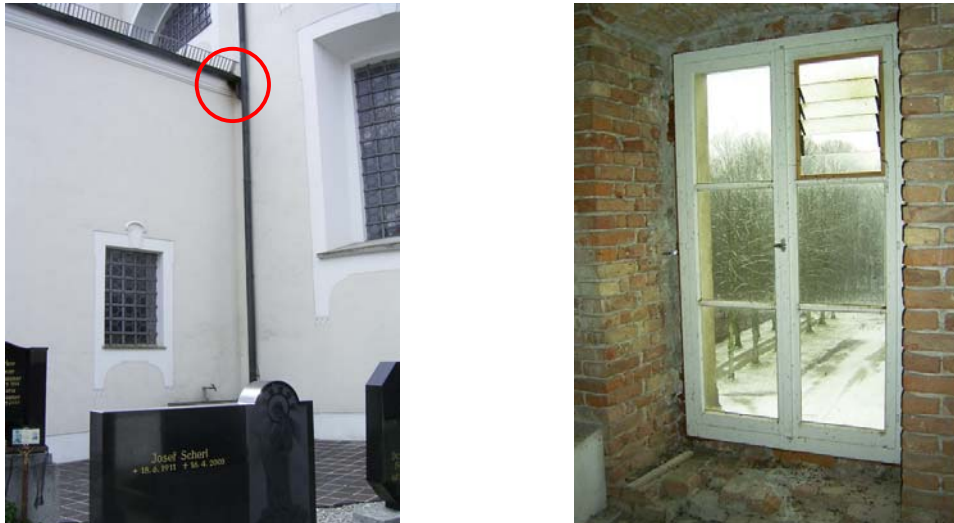
Fig. 4-22: Ingress passage below the guttering, identifiable by the dark discoloration of the wall (left), and ingress passage through diagonal window slats (right). Photos: A. Zahn

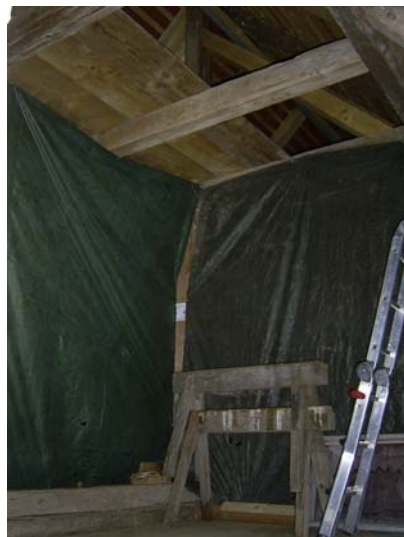
Fig. 4-23: Partitioning off the hanging places with dark sheeting, at Kläham (Bavaria, D). Photo: A. Zahn

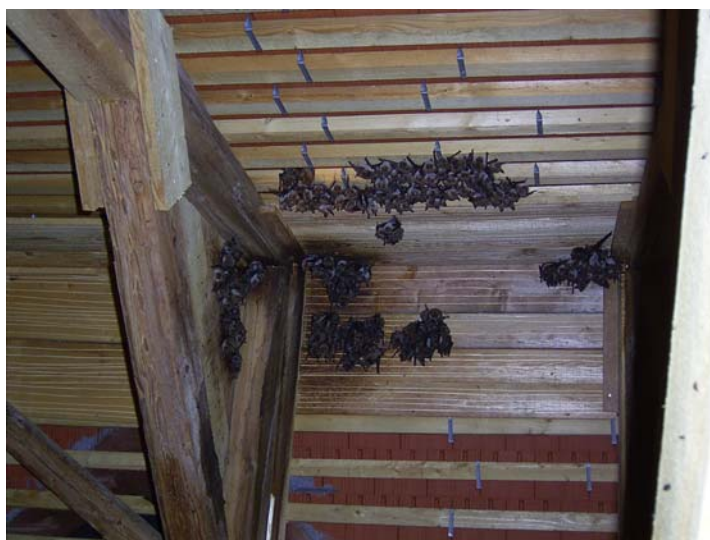
Fig. 4-24: Boards fitted at the ridge of Frichlkofen Church (Bavaria, D). The seamless rabbit and feather joints (tightly sealed at the ridge), enable warm air to build up. From as early as the first year, the animals hung from the new boards. Photo: A. Zahn

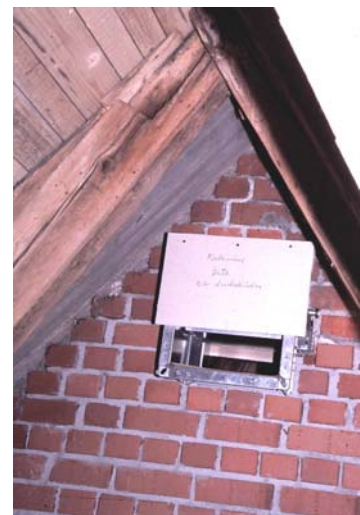
Fig. 4-26: In Beyharting (Bavaria, D) a vapour-permeable sheet was fitted along the ridge, making it possible for a certain amount of warm air to build up. Under the sheet there is boarding, from which the animals hang in summer, just as they did before renovation. If it is cold however (in spring), the animals roost in an adjacent roof frame with higher temperatures, which is also as it was in previous years. For this purpose they fly through a fire retarding flap (small picture), which was fitted about 70 cm below the former transit passage (a hole in the wall). Photos: A. Zahn

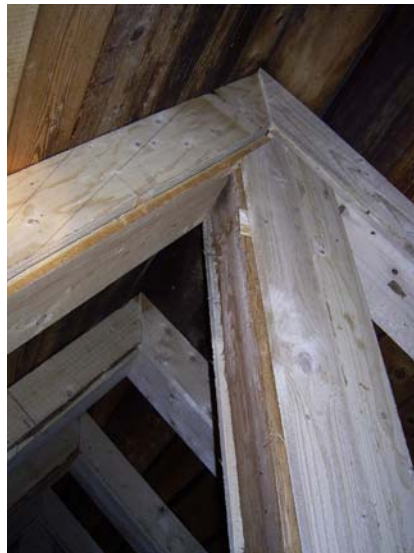
Fig. 4-27: In Au (Bavaria, D) load-bearing beams at the hanging places were covered with waste boards as a protection against droppings and urine. The animals were already hanging from the new boards in the first year, even though they preferred the hanging places located on the old roof laths. Photo: Andreas Zahn

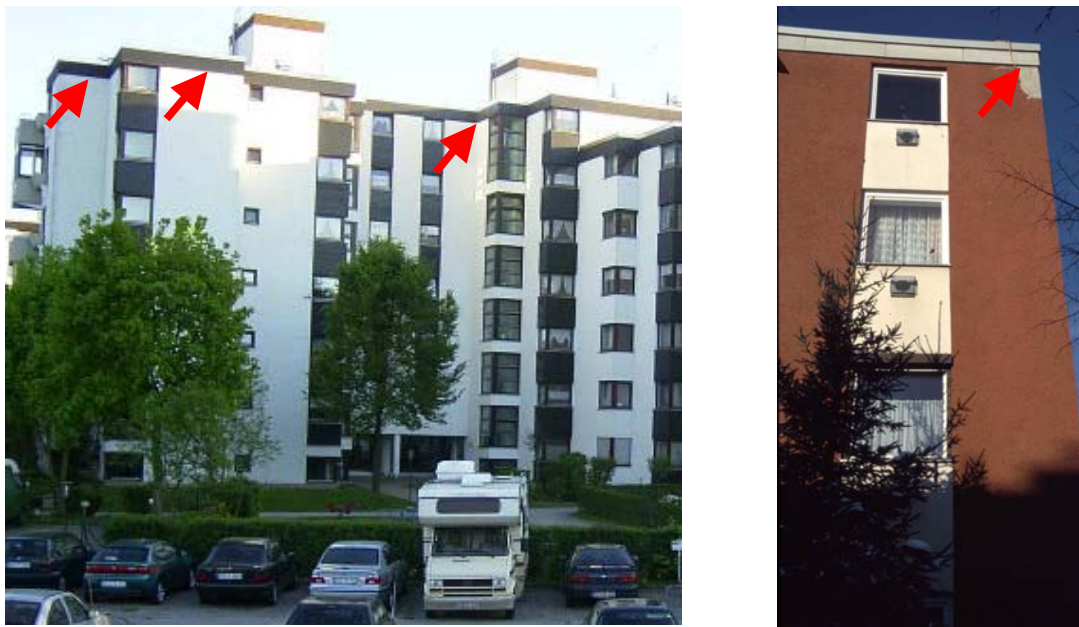
Fig. 4-28: Roosts of noctule bats behind wooden panelling (Wasserburg, Bavaria, D, left), and asbestos cement panelling (Waldkraiburg, Bavaria, D, right) at the edge of flat roofs. Photos: A. Zahn

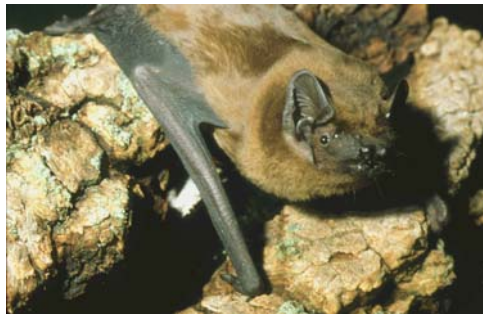
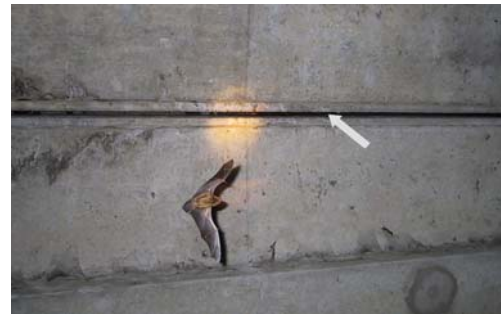
Fig. 4-29: A greater noctule bat and a colony's hanging place in the expansion joint of a bridge (Klagenfurt, Carinthia, A).
Photos: P. Angeli, C. Hebein

In Austria external lighting fitted below a colony of noctule bats, inhabiting the expansion joint of a bridge (fig. 4-29), caused them to abandon the roost. Because of the location it was not possible for the animals to seek out other hanging places. Once the lighting had been removed the roost was repopulated.

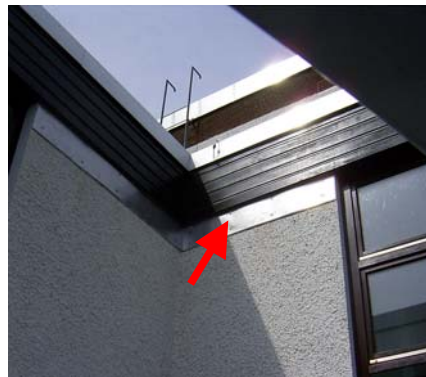
*Fig. 4-30: Metal sheeting “bat repellents”, to prevent noctule bats flying in above house entrances (Wasserburg, Bavaria, D).
Photo: A. Zahn*

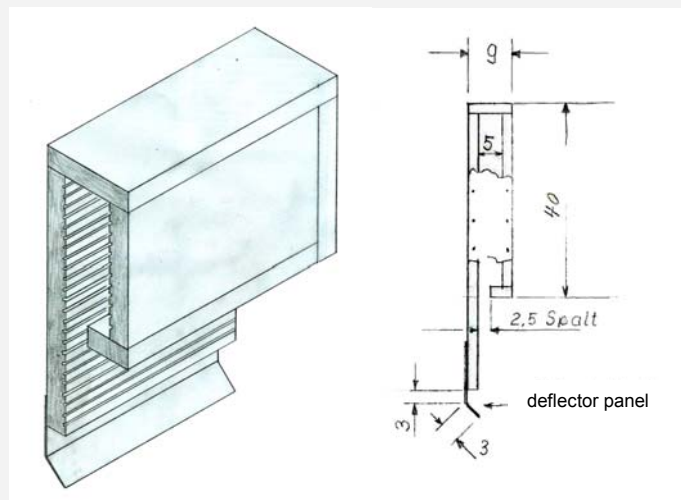
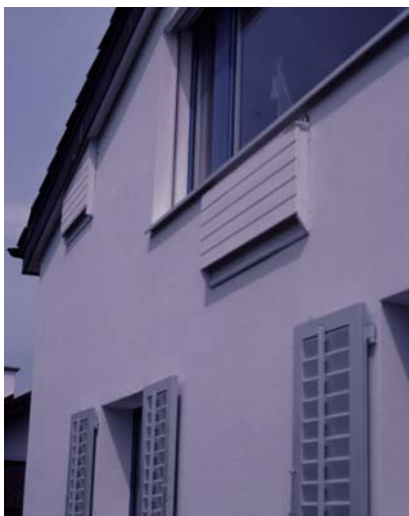
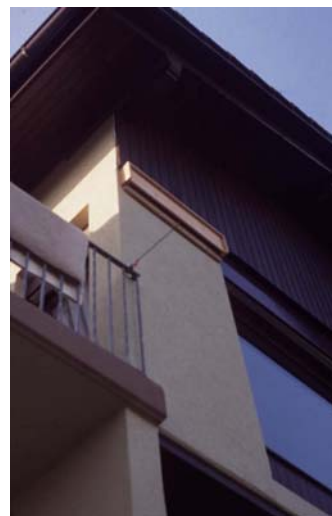
Fig. 4-31: Tried and tested alternative roosting place for noctule bats (Switzerland). Photos: A. Beck

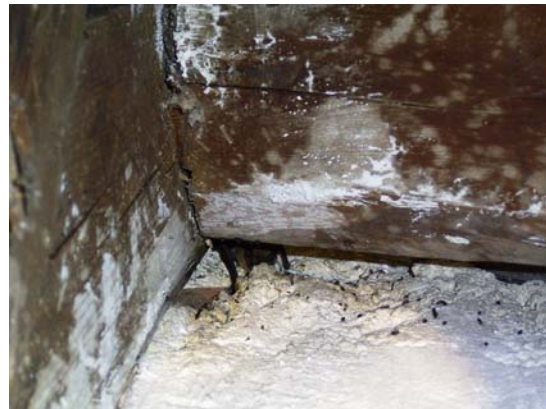
Fig. 4-32: The common pipistrelle. Right-hand picture: hanging place in a loft, between beam and wall. The animals go along under the ridge pole until they reach patches on the inner side of the house wall that are not completely plastered. They stay here if their hiding place in the crevices on the outside, become too hot. (Oberornau, Bavaria, D). Photos: A. Zahn

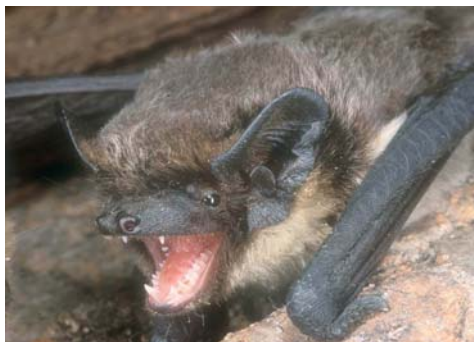
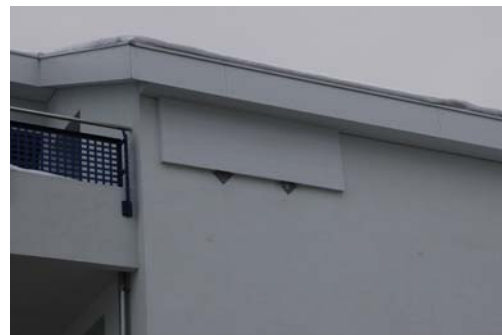
Fig. 4-34: A parti-coloured bat and an alternative roost of a colony of males (Buch am Irchel, Zurich, CH). The dark triangles are the openings, through which the animals can slip in. Foto: A. Zahn, K. Safi-Widmer

For aesthetic reasons the bat board was painted white, although the ingress and/or egress openings kept their dark colour (see fig. 4-34).

The alternative roost was accepted in the following year. It was even the case that significantly more animals than before were counted.

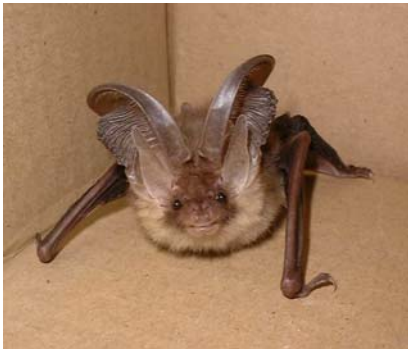
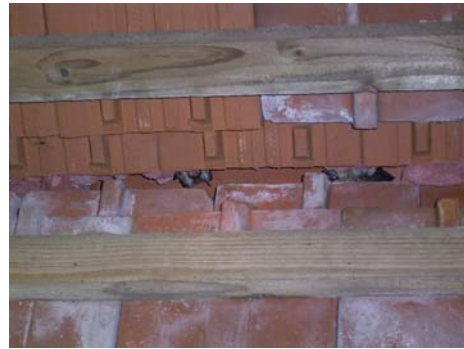
Fig. 4-37: The brown long-eared bat (*Plecotus auritus*), and a hiding place in the ridge area. Photo: J. Meyer, A. Zahn

In buildings, brown long-eared bats can be found in lofts, preferably in crevice roosts, such as tenon holes, beam collars or ridge crevices. False ceilings, and hollows in the brickwork are also used, but less often. Then animals also take up residence behind window shutters.

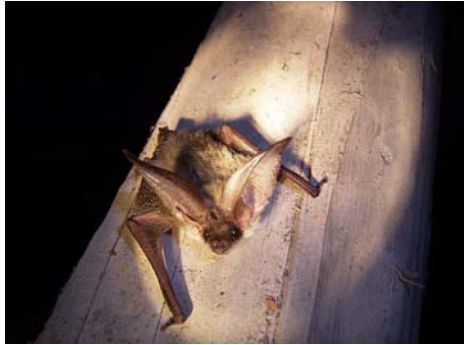
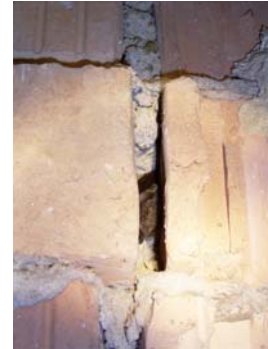
Fig. 4-38: The grey long-eared bat (*Plecotus austriacus*), and a crevice hiding place in brickwork. Photos: A. Zahn

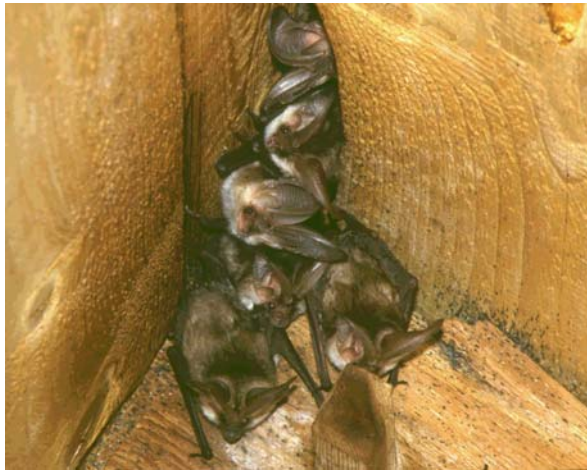
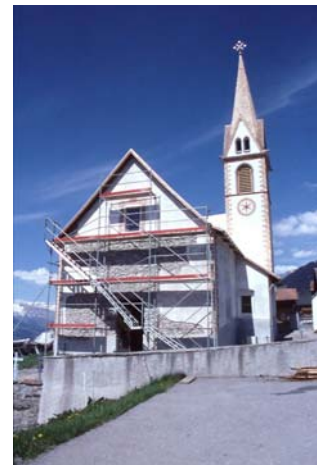
Fig. 4-40: A nursery colony of alpine long-eared bats in Thomatal Church (Salzburg, A), and the renovation of the Camuns Church (Grisons, CH). Photos G. Reiter, E. Mühlethaler

Renovation work needed to be carried out on the roof and its frame. The Cantonal Bat Conservation Representative for Grisons was the specialist monitoring the work (fig. 4-40).

A nursery of alpine long-eared bats (between 30 and 45 individuals) as well as individual greater mouse-eared bats lived in the church attic. The building needed to be renovated, and between 2001 and 2003 a range of renovation jobs were carried out on the inside and the outside of the church. When a check was made in Summer 2001, no animals could be found – presumably because of the disturbance brought about by the renovation work. When the roof had been renovated some years before, the individuals had already temporarily moved to the loft of the neighbouring presbytery. In 2001 however, it was not possible to check on this, but according to the sacristan that is where the bats were. When the nursery was checked again in 2002, the animals were using the church attic as usual. A count of the animals as they flew out registered 38 individuals. In the following years between 40 and 45 animals were also counted in the church attic. This leads to the assumption that the animals had come through the renovation largely unharmed.

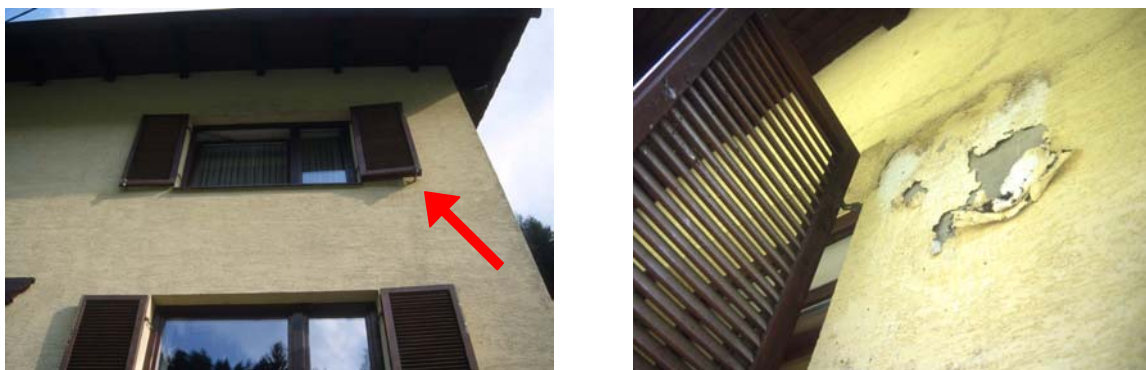
Fig. 4-42: Damage to a wall façade caused by the urine and droppings of a Barbastelle bat nursery behind a window shutter (Bad St. Leonhard, Carinthia, A). Photos: M. Jerabek

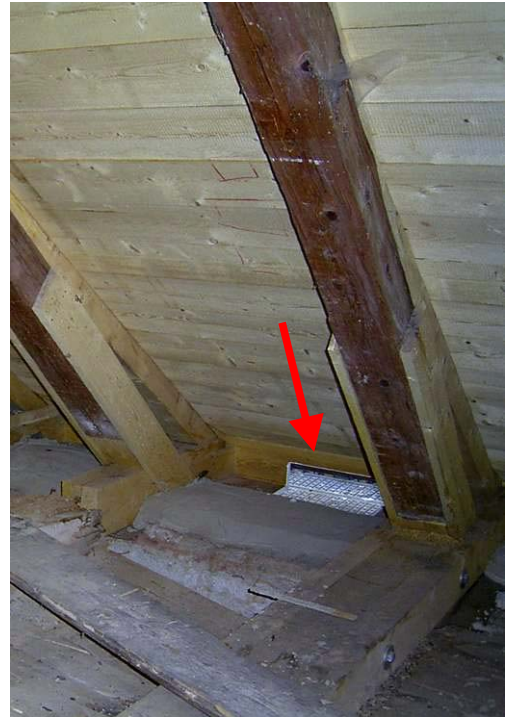
Fig. 9-2: Left: Offering an opportunity for ingress, by means of bent grating (arrow). The bent part should lie flush against the back of the grating, so that the animals cannot get caught in the opening (size in mm). Right: Ingress opening located at the base of the roof (between roof and wall)
